THE ELIMINATION OF POLLUTION FLASHOVERS IN SUBSTATIONS

R E Macey and *W L Vosloo

SUMMARY

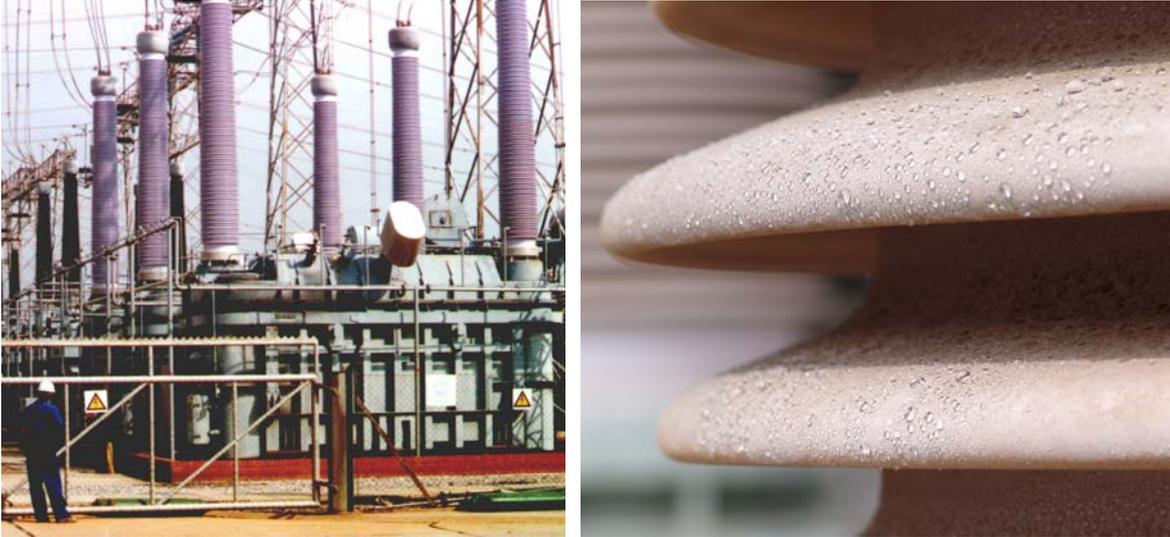
Figure 6: Coating condition at Apollo Converter Station after 8 years of service

An inspection of the insulator surfaces in 2005 showed no significant ageing of the coating layer or any indication that degradation of the material is accelerated with the application of a DC voltage.

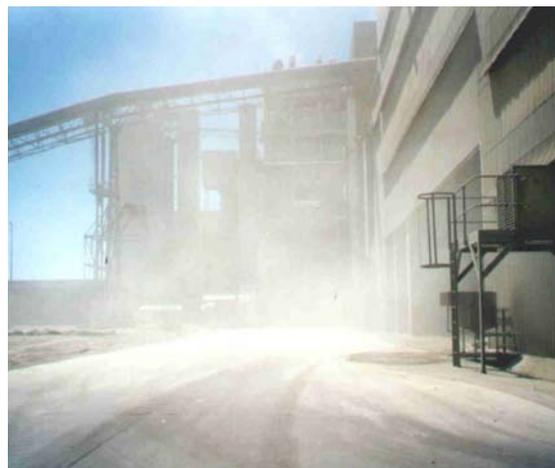
Figure 7: The cement dust laden environment of Whites North Substation

Whites North 88kV Substation in the town of Lichtenburg is located within the premises of an active cement works. As such, it is subjected to continual cement dust contamination which builds up and hardens on the surfaces of all apparatus, forming layers up to 4mm thick. Needless to say, flashover of the insulation was common.

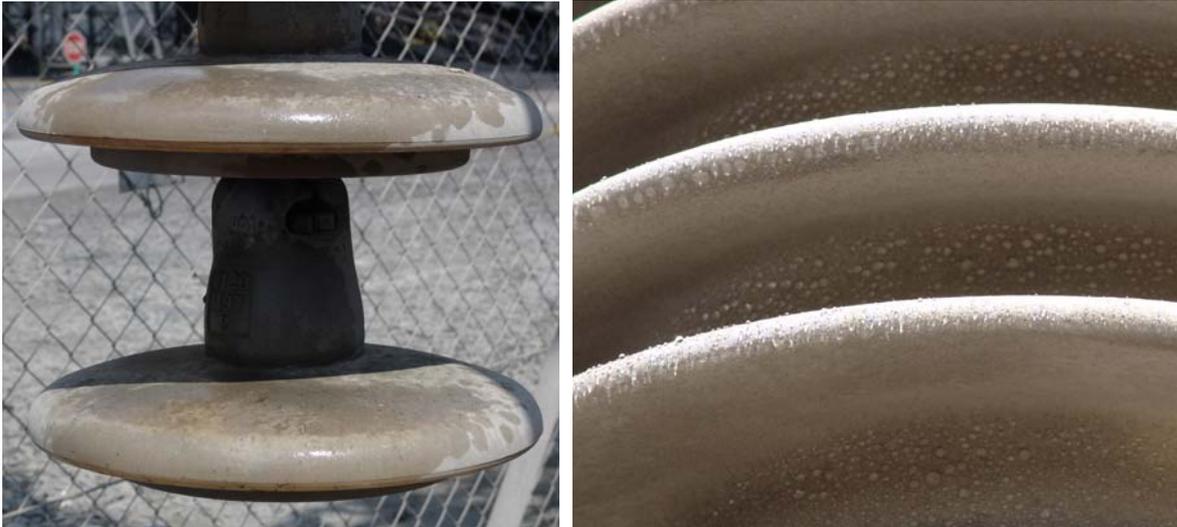
Figure 8: The hydrophilic dust-covered glass surface compared to the hydrophobicity of the coated ceramic.

An examination of the coating in 2005 showed that, in spite of the thick contaminating layers, the surfaces were still hydrophobic and no peeling or deterioration of the coating was evident. The condition of the coating compared to uncoated glass disc units installed, unenergised, at the time for the purpose of pollution severity measurement is shown in Figure 8.
